**ZONING BOARD OF ADJUSTMENT
TOWN OF HANOVER, NH**

**APPEAL OF AN
ADMINISTRATIVE DECISION**

RE: 34 Greensboro Rd, Appeal of Administrative Decision

Wetland Boundary Plan
Christ Redeemer Properties
Greensboro Rd. Hanover, NH
August 26, 2025

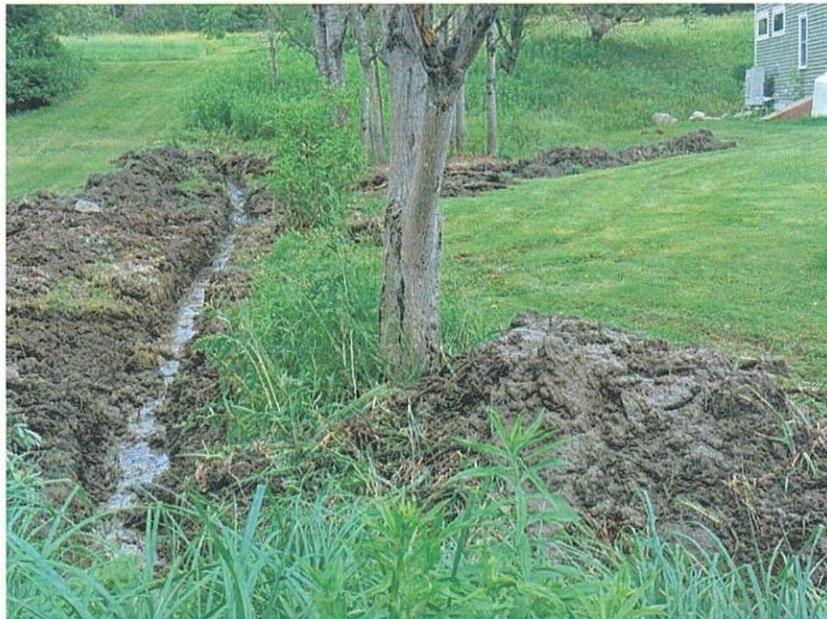
The work in question consisted of digging a "Y" shaped trench starting at the culvert, extending North for 50 +/- feet and then splitting when it reached the stand of trees. See picture below, and note water running in the trench from North to South.

This trench was then lined with filter fabric, and a perforated pipe was installed which outlets right by the head of the culvert. The trench was backfilled with crushed stone, and then topped with dirt and the area was re-seeded. The native soils from the excavated area were removed and new soil was brought in to backfill the trench. Additionally, all the native vegetation was removed and the area was replanted with regular grass seed like is typically found in non-wetland lawn areas.

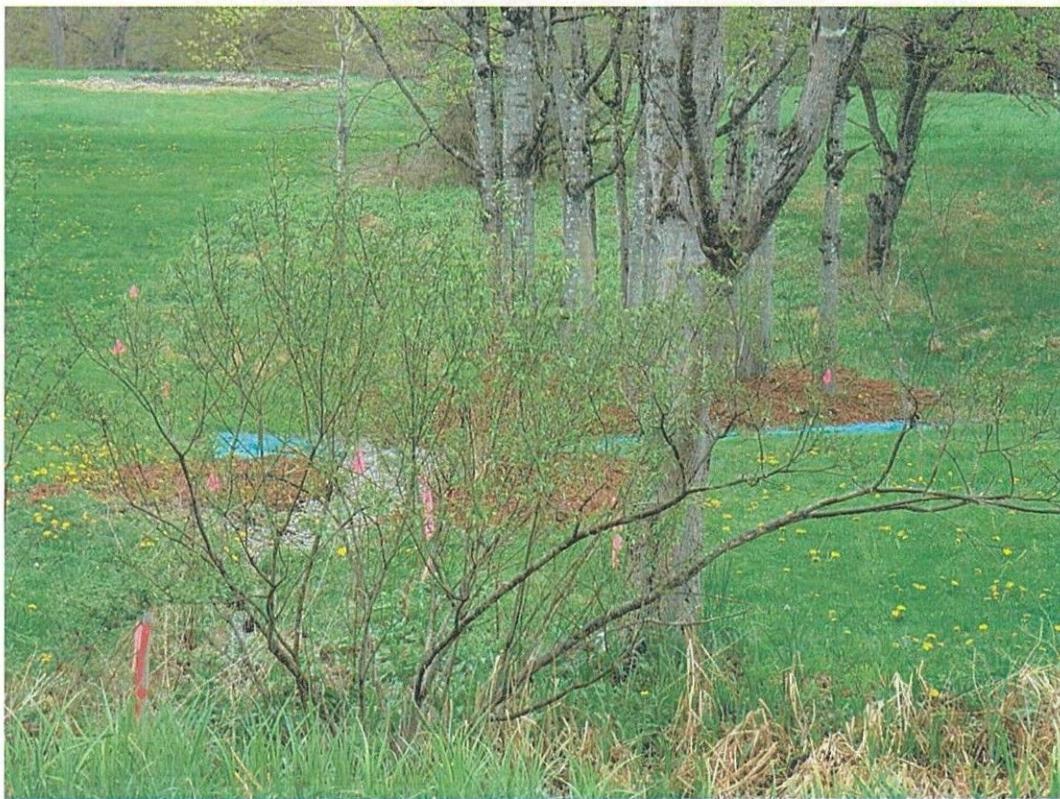
1. Audra Klumb, A&D Klumb Environmental makes 1st visit May 7, 2025 and marks the wetland with pink flags. (see picture below) These flags track almost exactly the limits that Rick VandePol outlined in his 2018 report.

Audra did the original Wetlands delineation for CRC.

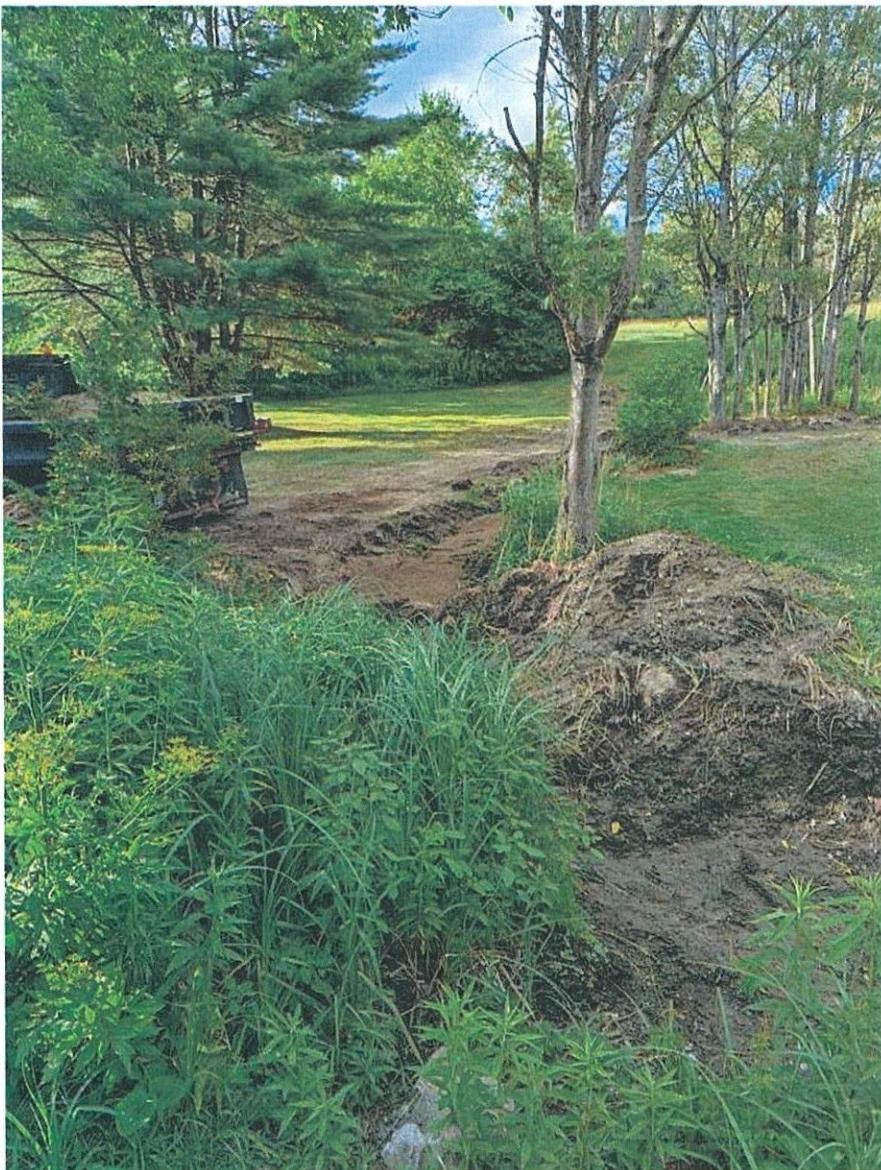
4. July 7-Work restarted despite the fact that CRC had not been granted a permit, the Contractor was once again asked by the ZA to stop the work and get the appropriate permit. The contractor continued the work anyway and in fact that day removed native soils and vegetation and brought in new soil to backfill over the French drain.

(Note different colored soil in trench and all native vegetation disturbed)

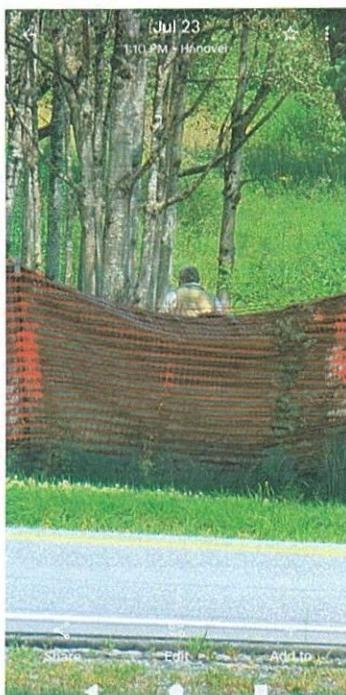
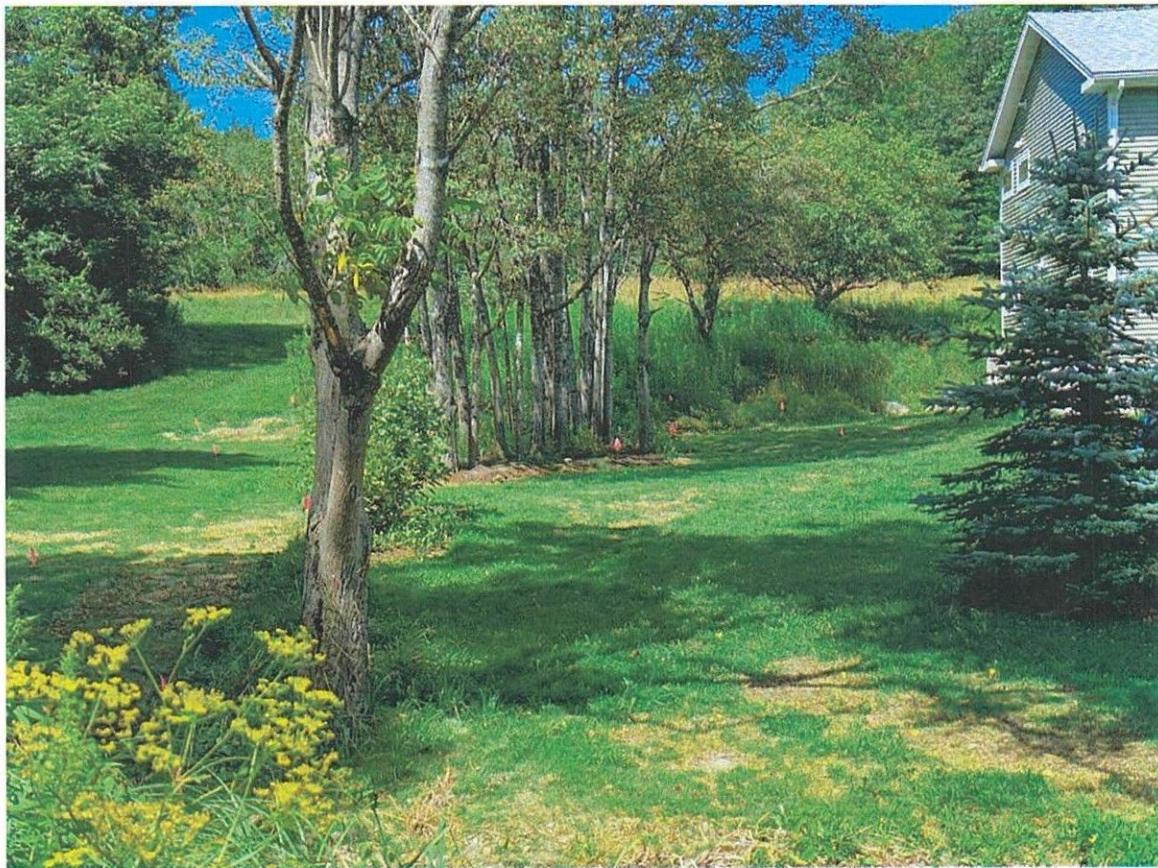
6. July 23- Audra Klumb makes 2nd visit and again marks the the wetland in the same locations

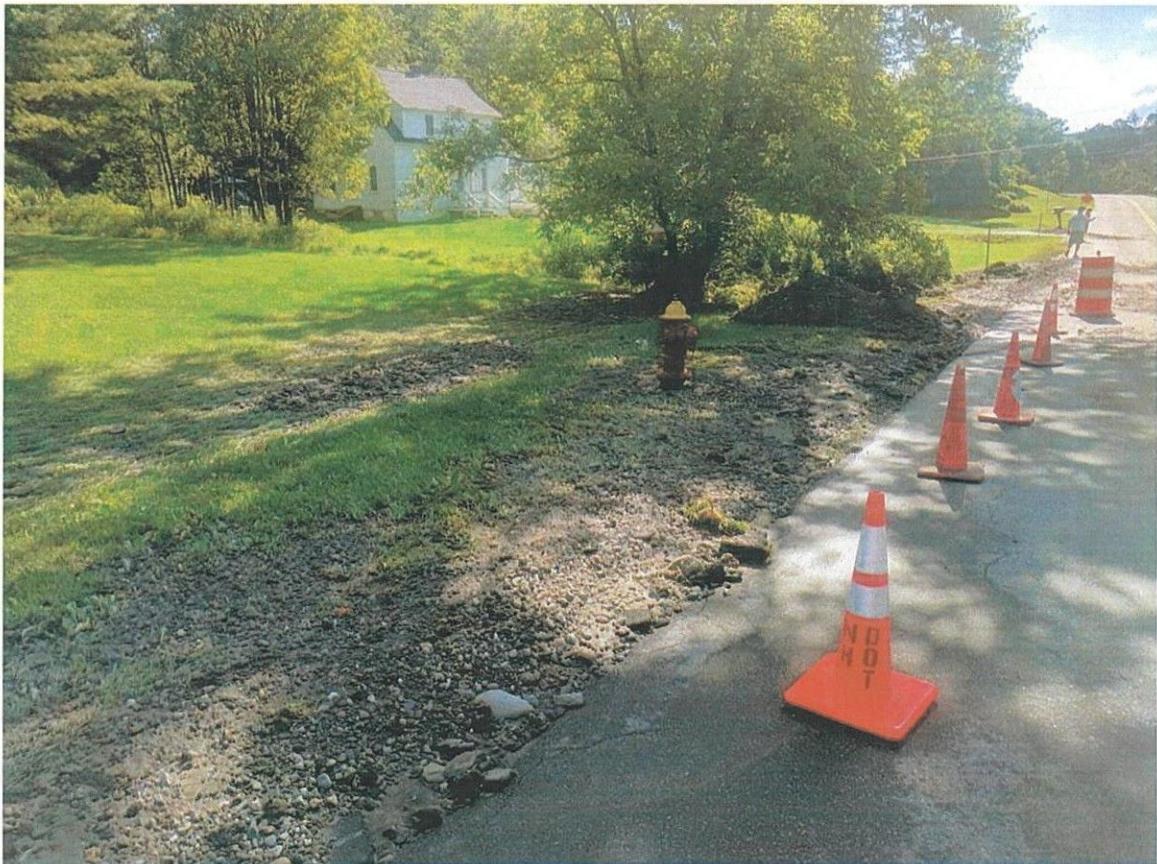
This picture is looking East along Greensboro Rd. It was taken in July 2017 after the road washout. Note the long grass between the 2 shrubby areas. This is precisely the area where CRC installed their "French drain". The reason this grass is long is because this area is always too wet to mow except in drought conditions.

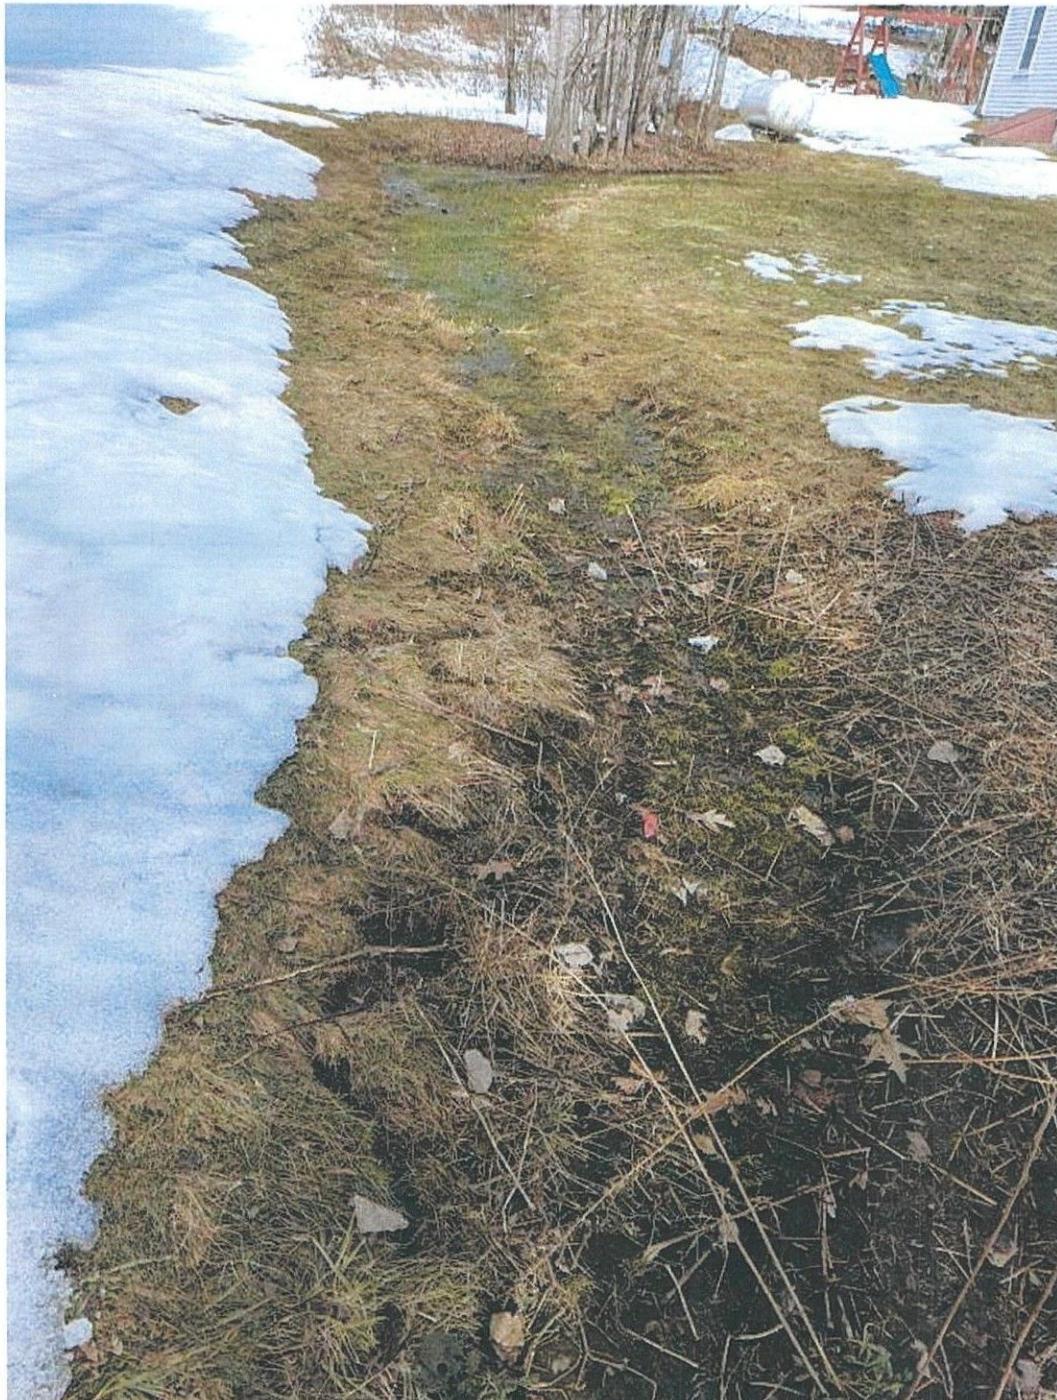
This

picture is looking North at the wetland in late winter. Note that the area of snow melt very closely matches the area marked twice by Audra Klumb with pink flags, and also very closely matches the area delineated by Rick VandePol. You can also see water running along the surface from North to South.

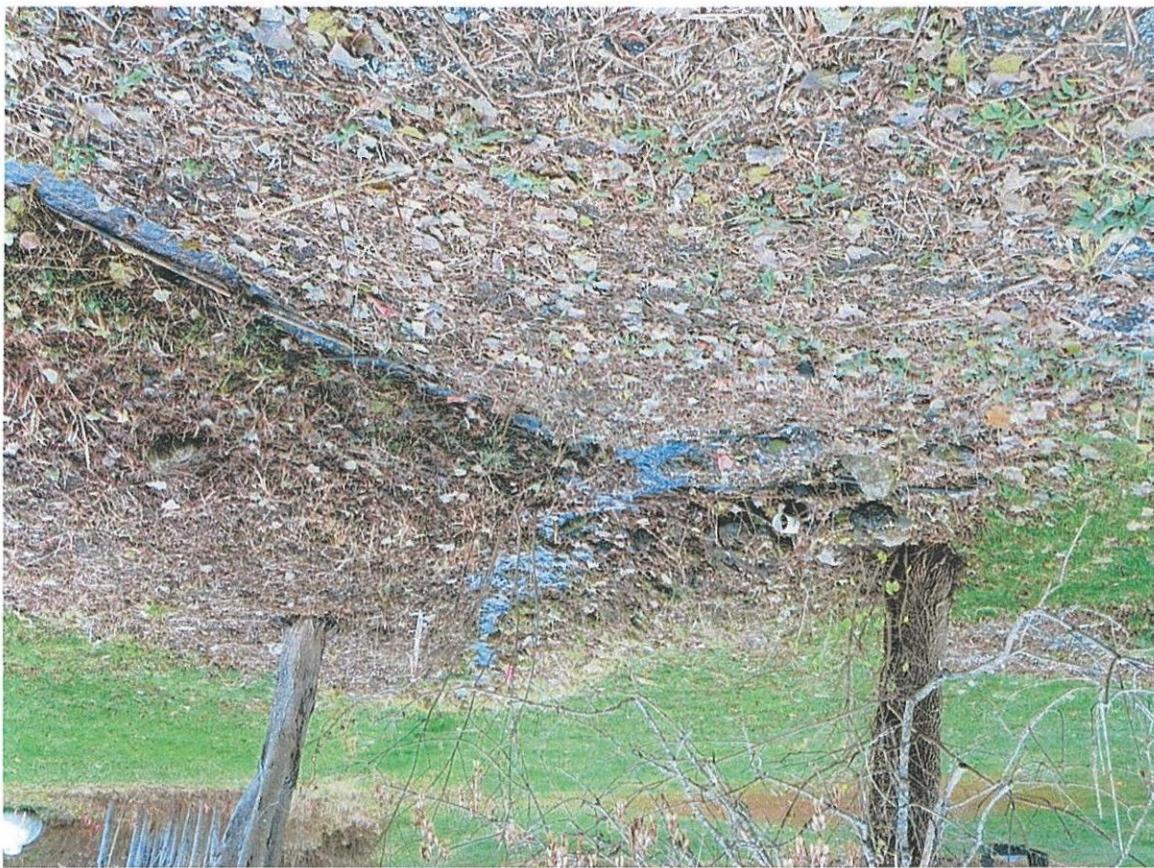
South.

This picture was taken from Greensboro Rd in November. Water is very clearly visible running from North to

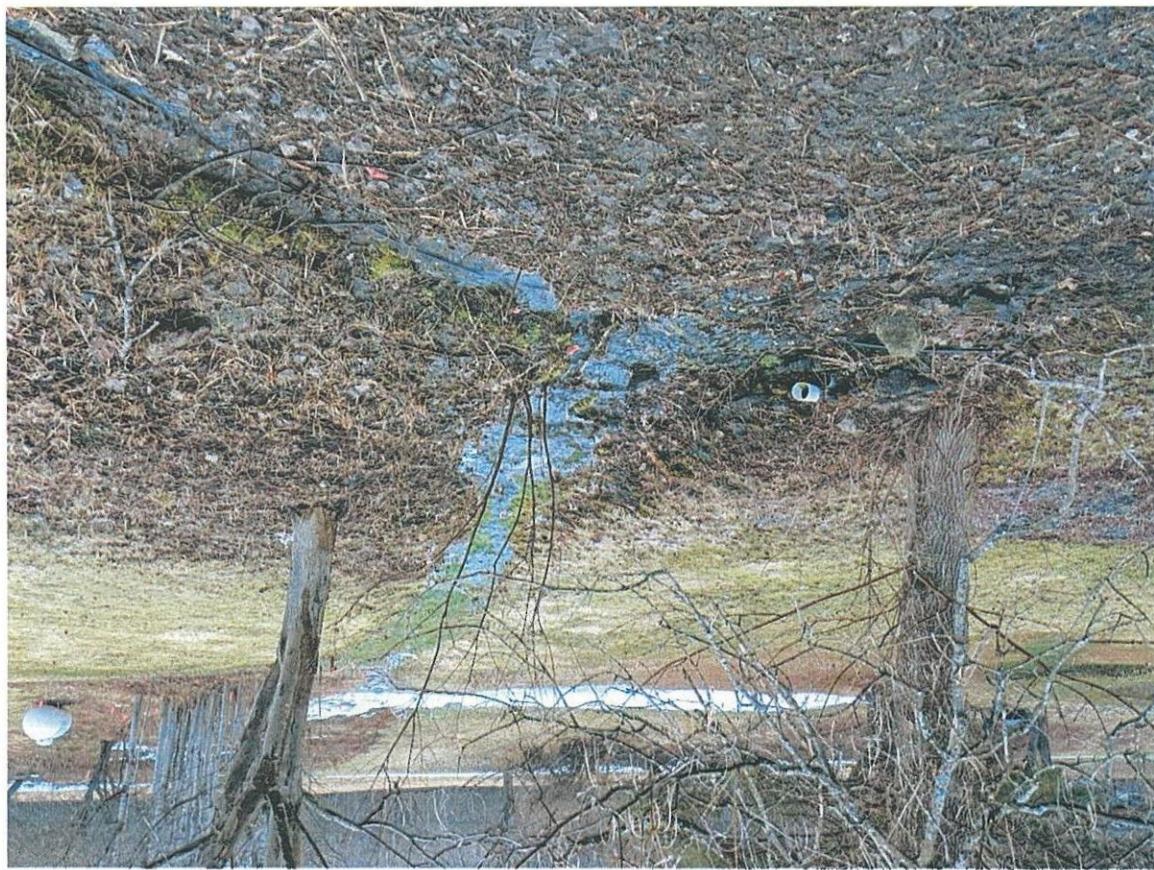
brown due to the late winter season.

Another picture from Greensboro Rd., this one taken in late March. Note again the water running between the two areas. Also note that the vegetation in the wetland is already turning green while the lawn areas are the two areas. Also note that the vegetation in the wetland is already turning green while the lawn areas are

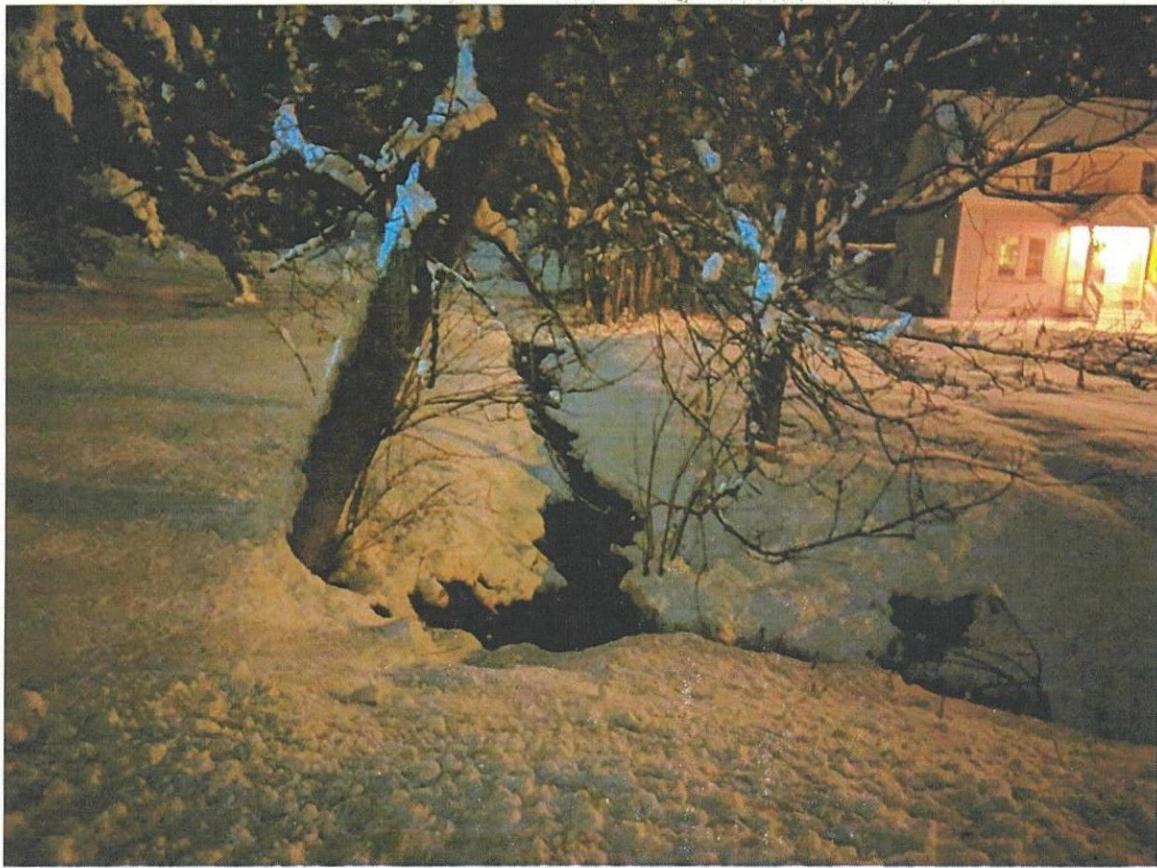
This was taken in January, after a heavy snow. Note that despite the snow cover everywhere else, the presence of the flowing water has melted a channel thru the snow in the wetland.

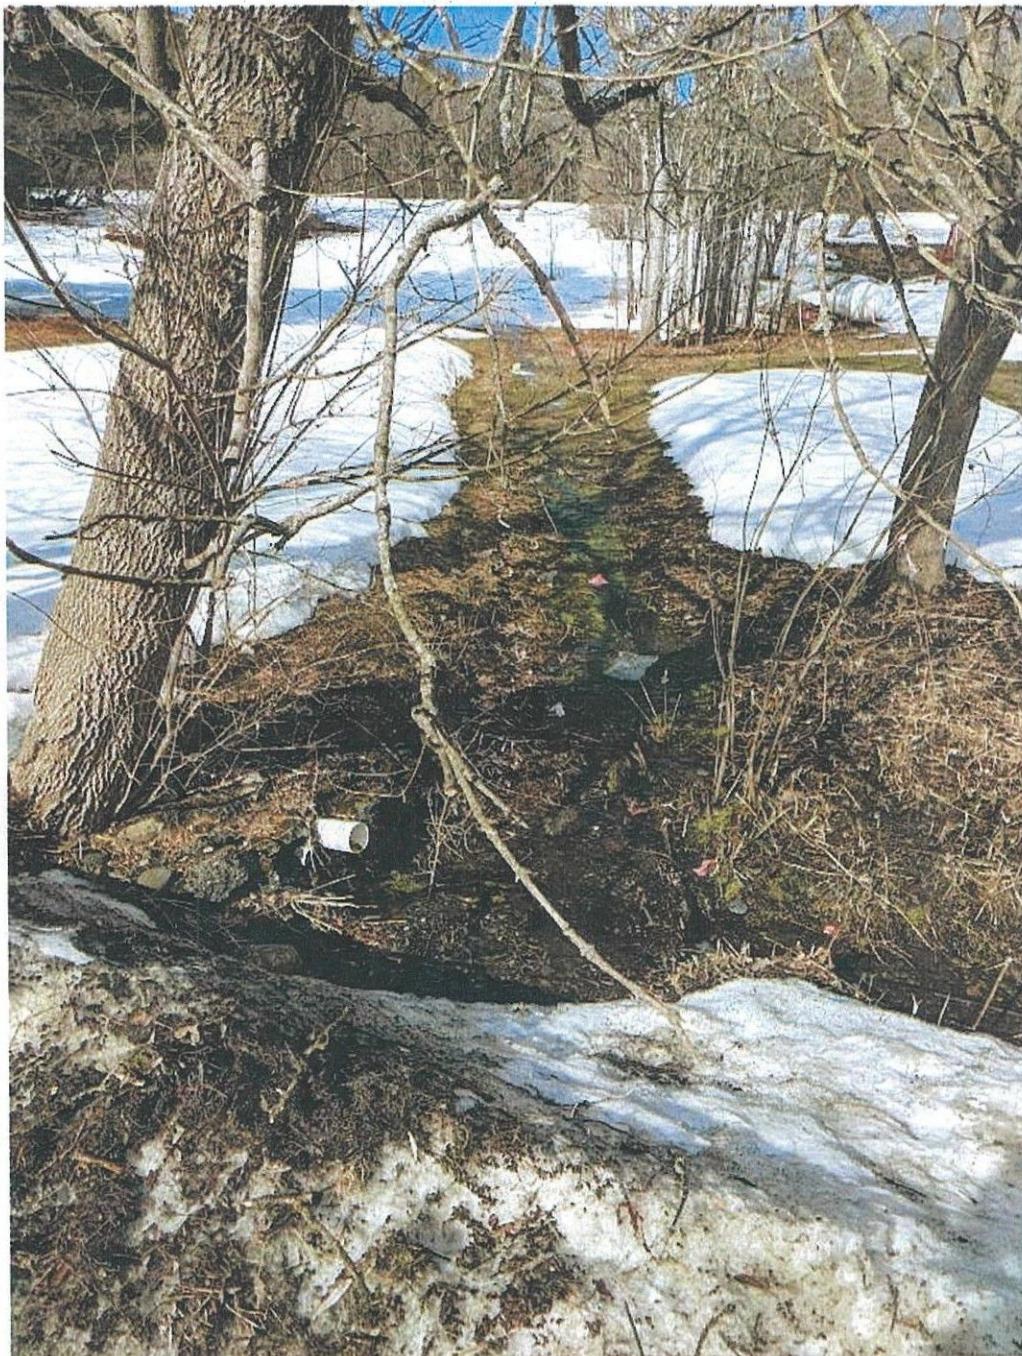
Another late winter picture. Note again the melted snow pattern matches Audra Klumb's pink flag locations almost exactly. Note also the running water on the surface.

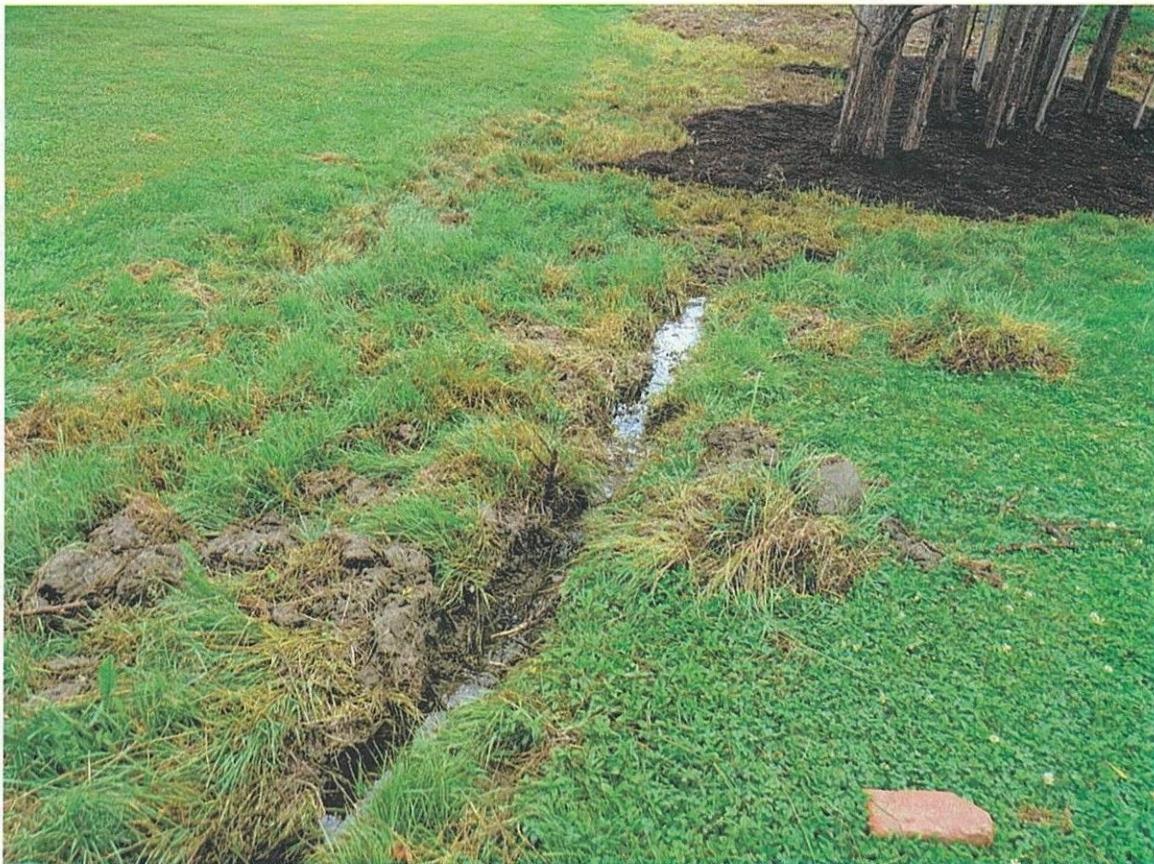
This picture was taken in July 2019 after one of CRC's many attempts to dry the wetland. You can see that there is flowing water in the hand dug trench. Note that the lawn has not been mowed because it is too wet for a mower. Note also the fresh bark mulch that CRC spread under the trees in an effort to soak up water.

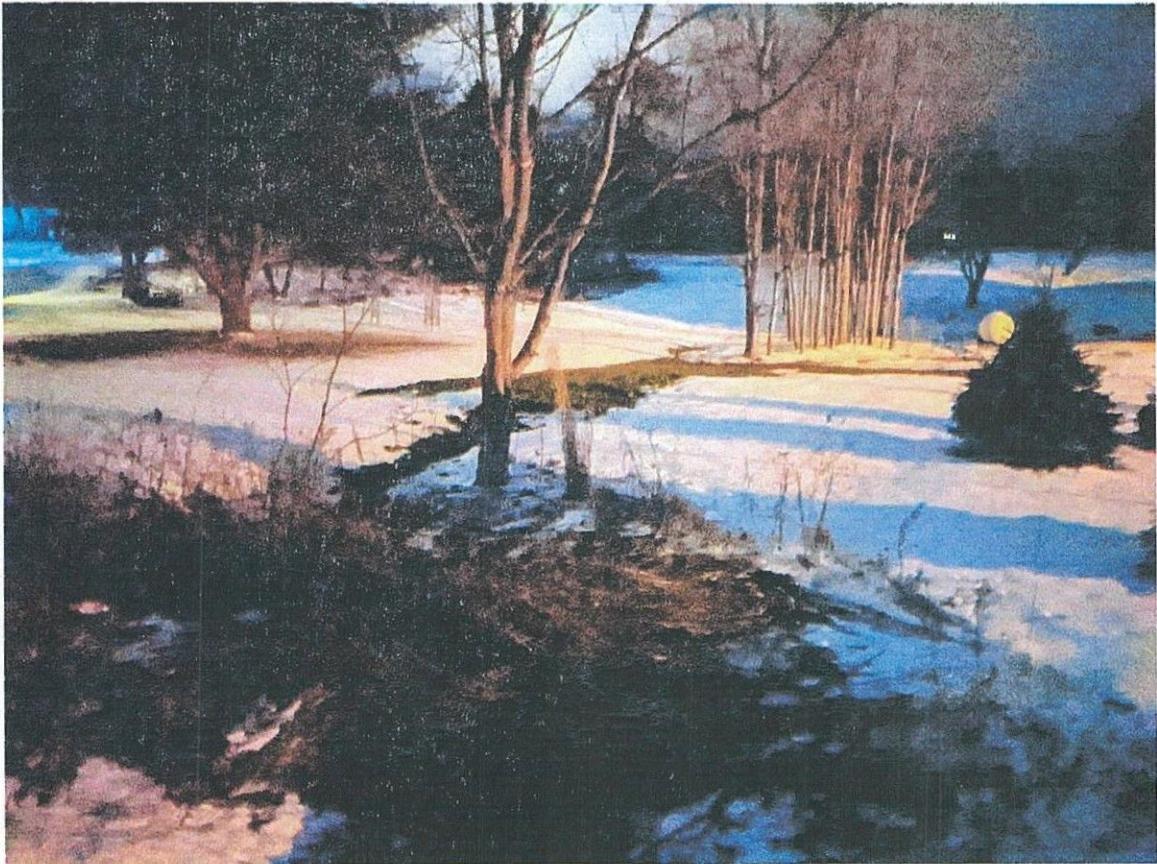
Another winter picture, from January 2021, showing the same characteristic snow melt pattern exactly where the wetlands delineation is.

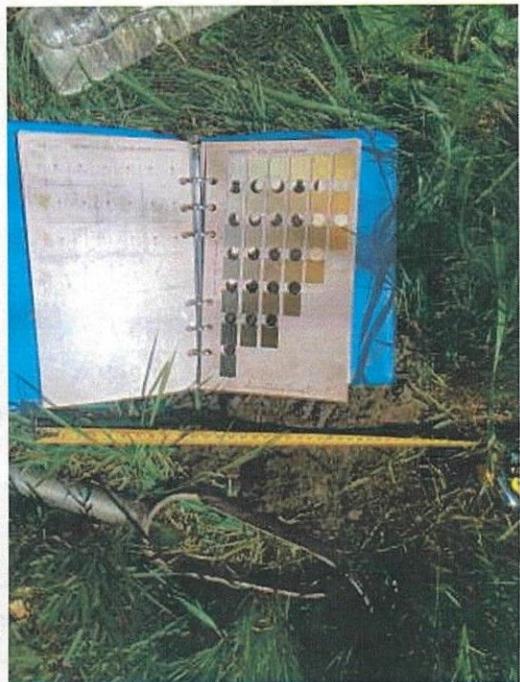
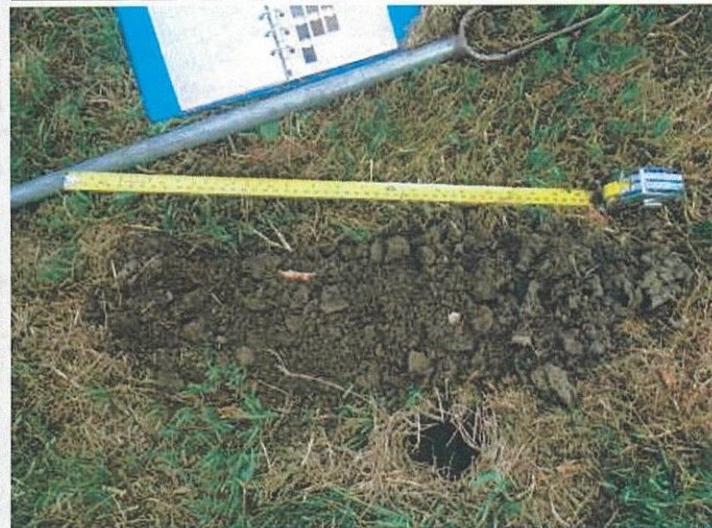
Left: soil materials in B horizon, TP#2 showing low chroma colors (2.5 3/1) at depths of less than 16 inches; Below: soil profile shot of TP#3 showing redox concentrations in upper part along with generally low chroma colors; note all materials silt loam

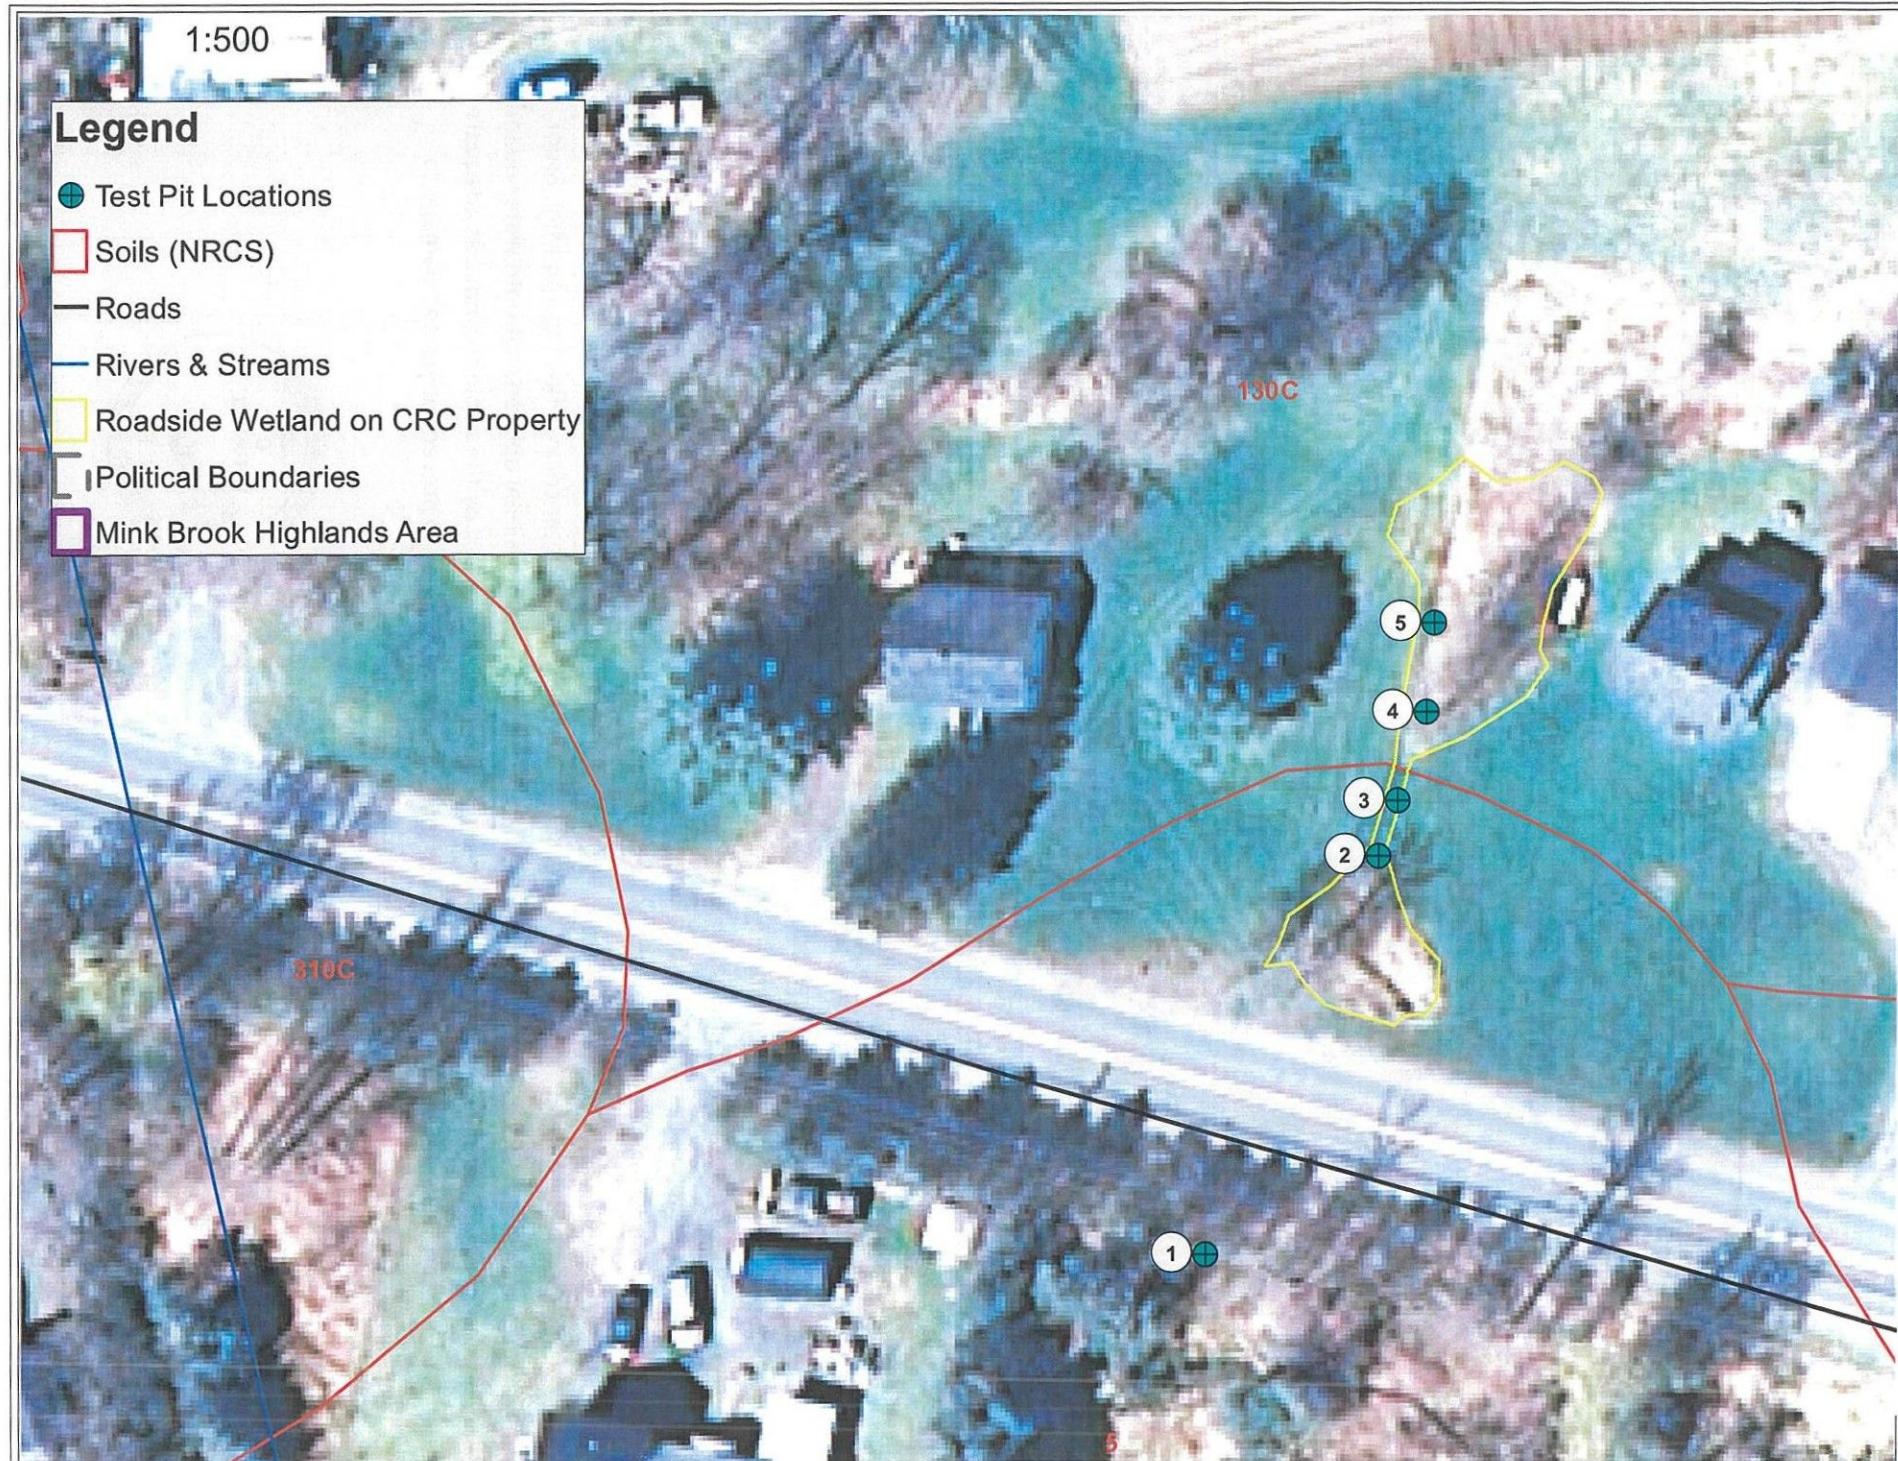
7/18 - Greensboro Rd - Site Visit #1 - solo,

(132) SITE (1410) Meet Chris Andino (1420) Conduct TP's on CRC prop. (1630) survey Acker side (1700) Lu weather: mostly sunny + 38°C, winds N (W), occ. cumulus, RH high

conditions: dry soil & subsoil, W.T. v. low

1/2-2 1/2" A 10YR 2/2 (moistened), many fine roots

1/2-6 1/2" A 10YR 4/4 vfg, few gravel, friable, granular (moistened) vfg
